Inspection Report

Mine Name: Cameron #1

Operator Name: Temple Mountain Energy

Permit number: S0470036

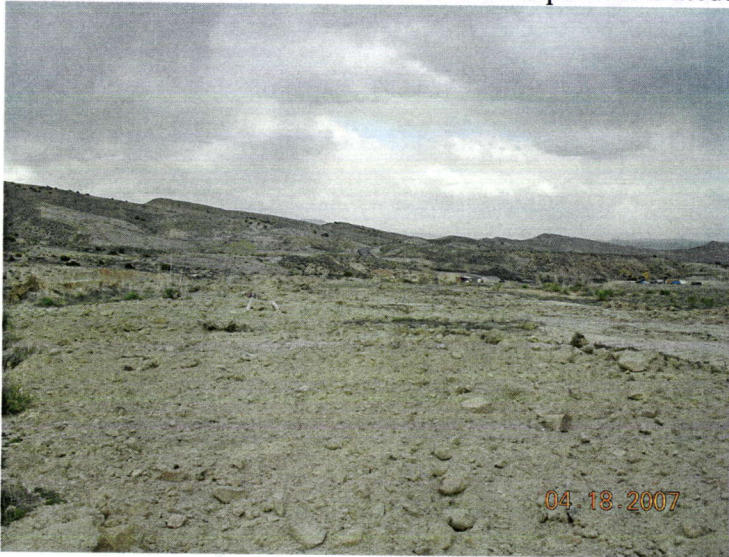
Most of the grading in the reclaimed areas was completed in December 2006, and I believe seeding was finished by February 13, 2007. I understood the operator would use a seed mix that included Russian wild rye, crested wheatgrass, Indian ricegrass, Palmer penstemon, and fourwing saltbush; however, we found some legume seedlings indicating a different mix might have been used. We found a moderate number of seedlings, especially in depressions.

Photo 1 An area that was recently graded and seeded.

The operator needs to continue to monitor those areas that have been seeded.

I recommend that forage kochia be included in the seed mix for future seedings.

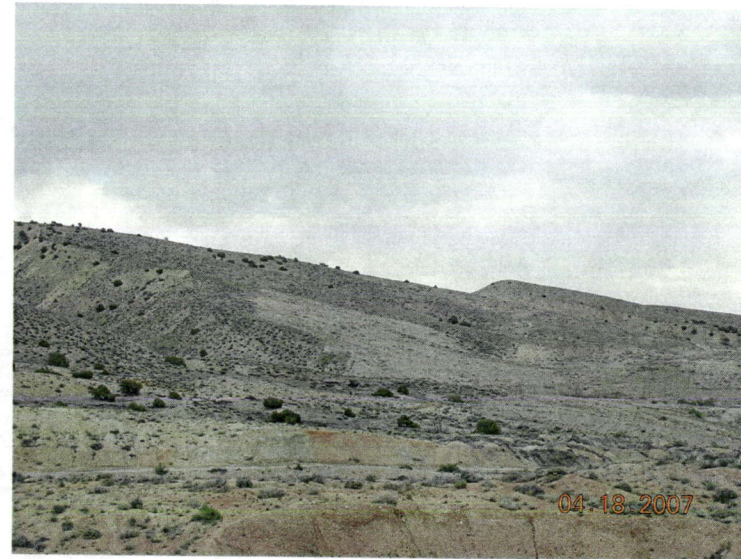
Several areas around the permitted mine have been previously mined, and Mr. Bower and Mr. Runquist pointed out some of these areas. Photo 6 shows an area where there was apparently a hill that was mined. There is a waste dump shown just to the right of center in Photo 5. The lighter colored area near the center of Photo 4 is also a previously disturbed area.

Photo 4. The lighter colored area on the hill near the center of this photo was apparently disturbed by previous mining operations.

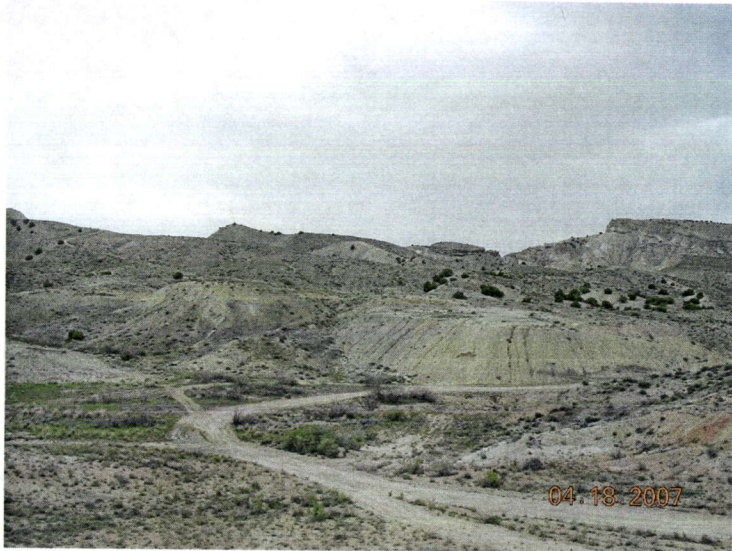
Photo 5. What appears to be a waste dump is in the center right of this photo.

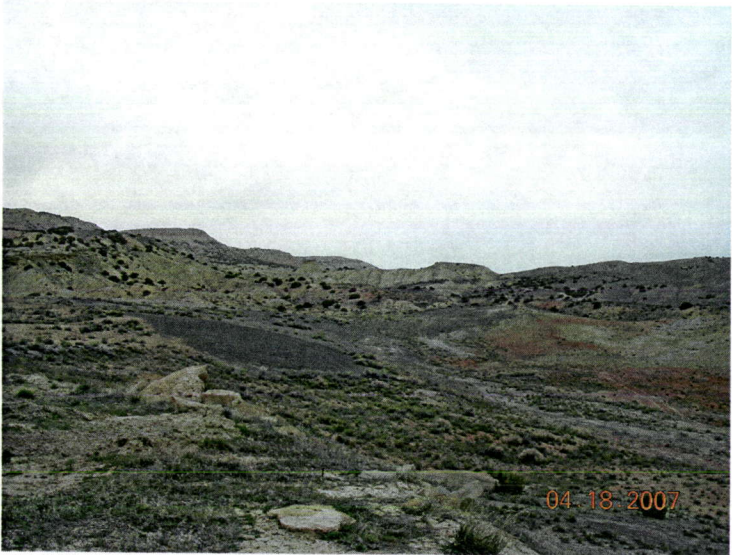
Photo 6. Just to the left of center is an area that was once a hill that was mined for asphalt.

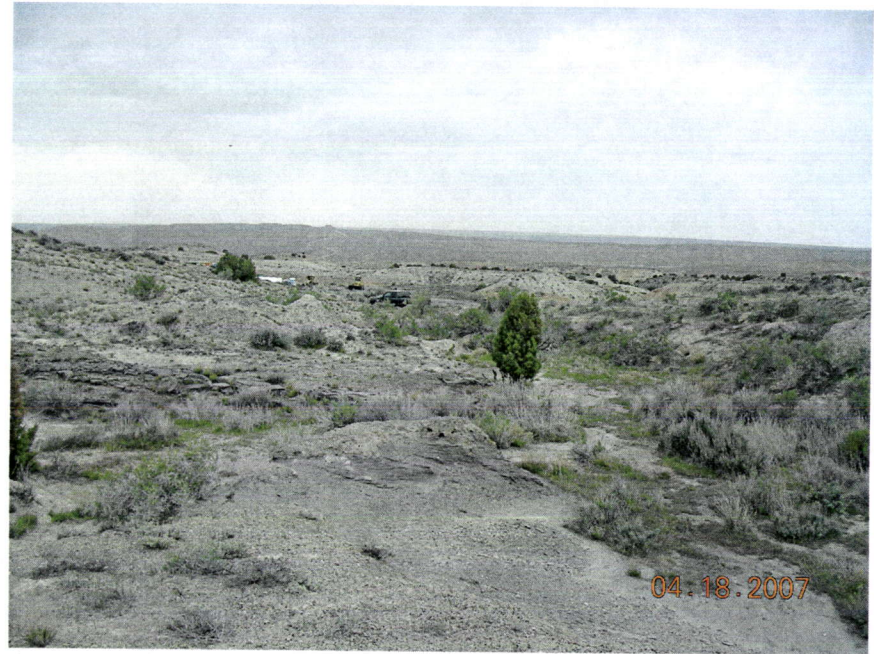
The operator has proposed a new small mine, S0370088, the TME AR Lecy Mine, near the existing mine. During the inspection, we looked at some of the area that would be disturbed by this operation (Photo 7). This area has some asphalt outcrop, but most of the area has some soil, including cryptogamic soil. On April 18, 2007, the Division sent a letter to the operator finding the notice complete and stating that a reclamation surety needs to be submitted.

Photo 7. This is the area the operator proposes to mine.
